Repair of porcelain restorations: Four case reports

*Department of Prosthodontics, Faculty of Dentistry, Pamukkale University,
Denizli, Turkey*

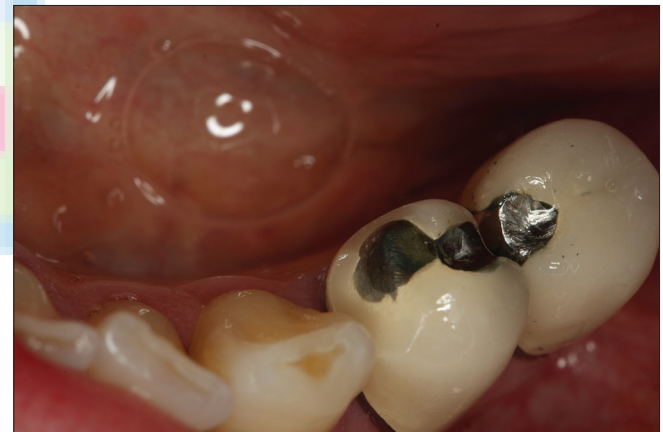
A 53-year-old female patient applied to the clinic for the rehabilitation of her fractured restoration. Upon intraoral examination, a mandibular removable partial denture was noted which utilized two metal-porcelain crowns with rest seats. The mandibular left premolars had crowns with a fracture of the mesio-occlusal surface. The restoration had been completed about 1-year previously. The patient

Figure 1: Occlusal view of the block crown with a crack of the mesio-occlusal part

refused the removal of her fixed restoration. Therefore, the restoration was repaired intraorally. The patient was satisfied with the treatment [Figures 1 and 2].

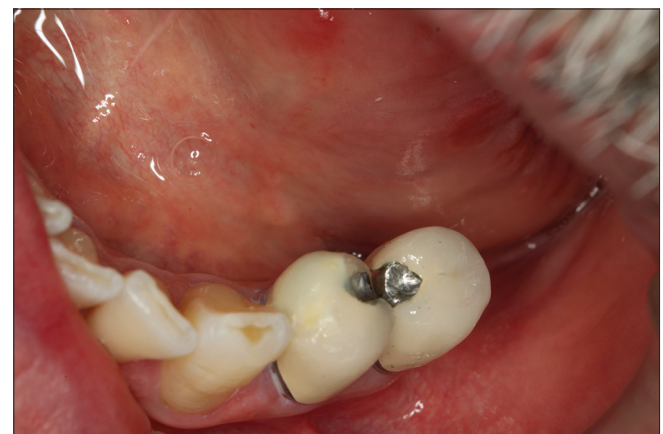
Figure 2: Definitive aspect of the porcelain repair

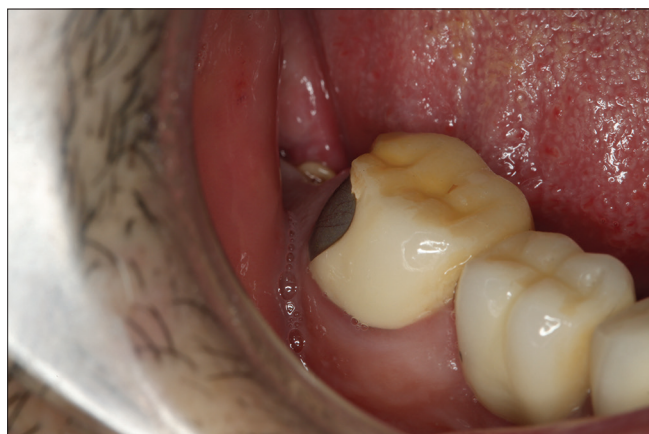
A 48-year-old male patient has a 4-unit metal-porcelain fixed partial denture with good marginal adaptation. The patient's chief complaint was that the porcelain had chipped from the metallic structure in the mandibular second molar tooth most likely due to a premature contact. The patient refused replacement of the fixed partial denture. In addition, the restoration had a good marginal adaptation. Thus, as a treatment option, porcelain repair was selected, and the restoration was repaired intraorally [Figures 3 and 4].

Figure 3: Clinical view of the chipped porcelain in the distal surface of the mandibular right second molar

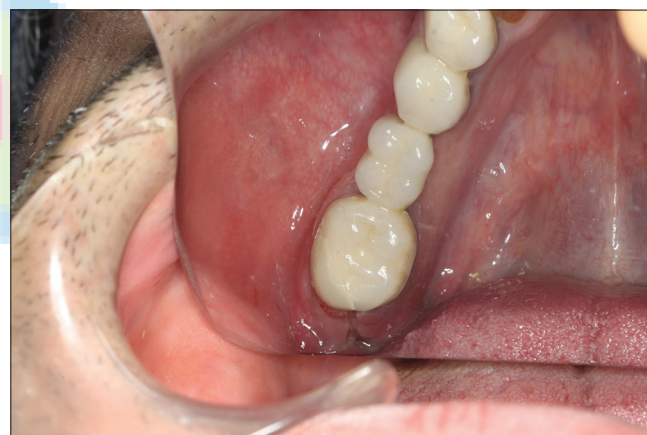
Figure 4: Definitive view of the repaired restoration

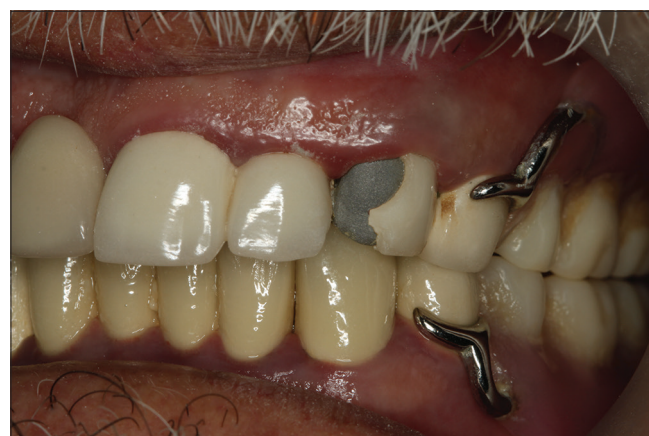
A 56-year-old female patient with a 7-unit metal-porcelain fixed partial denture, which was 18 months old, presented with fractured porcelain from the metallic structure in the maxillary left canine. In addition, the patient had a removable partial denture whose retentive crown had been damaged during the restoration. For financial reasons, the patient

Figure 5: View of the case with a fractured porcelain in the mesio-buccal surface of the maxillary left canine

refused the denture replacement. Therefore, the restoration was repaired intraorally [Figures 5 and 6].

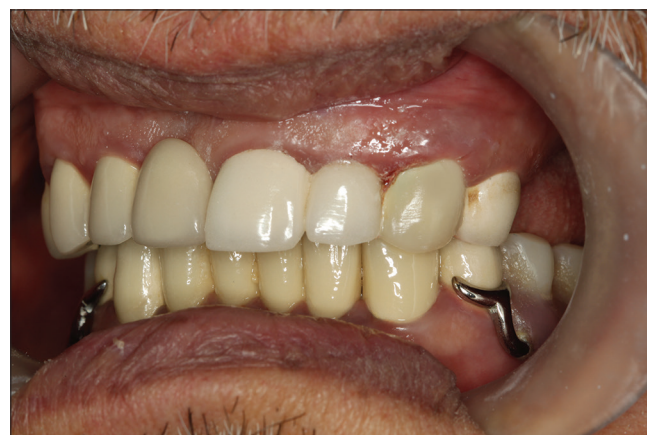
Figure 6: Definitive aspect of the repaired restoration

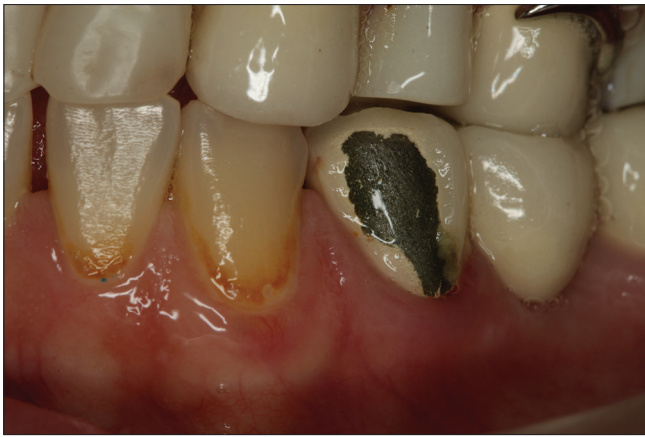
A 49-year-old female patient with a 1-year old 3-unit metal-porcelain fixed partial denture presented with porcelain fractured from the metallic structure in the mandibular first premolar tooth. The restoration had a good marginal fit, and the gingival tissue was periodontally healthy. Treatment options were explained to the patient and the patient selected repair of the restoration intraorally. The patient was satisfied with the treatment [Figures 7 and 8].

Figure 7: View of the fractured porcelain in the buccal surface of the mandibular left first premolar

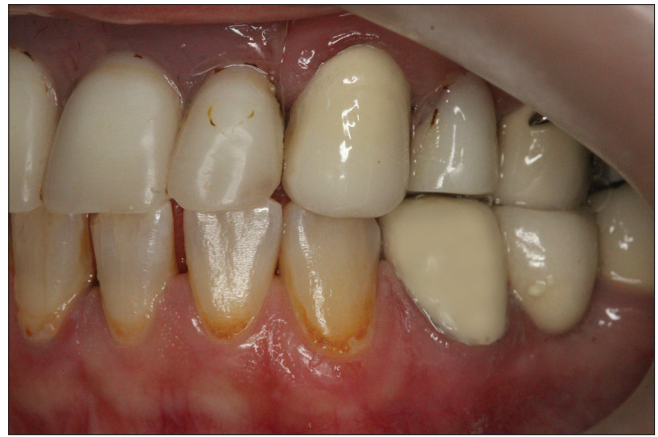
Figure 8: Definitive view of the repaired restoration
