# Control of Aeolian Noise Generated by the Finned Balustrade of a Freeway Pedestrian Overpass

During construction of a new freeway in Melbourne, it was found that tonal wind-induced noise was being generated by the finned balustrades of architecturally-designed pedestrian overpasses which had been installed at several locations along the route. As the level of wind-induced noise was unacceptable at residences in the vicinity of the overpasses, a solution to reduce or eliminate the noise had to be developed. The solution needed to be practical to retrofit to the existing structure, while satisfying strict project constraints in relation to urban design, design life, and safety in design rules. This paper outlines the investigation that was undertaken to determine the wind-conditions under which the noise occurred, discusses the noise-generation mechanisms that were established to be causing the noise, and presents a summary of the potential solutions that were identified through theoretical analysis, wind tunnel modelling and field trials.

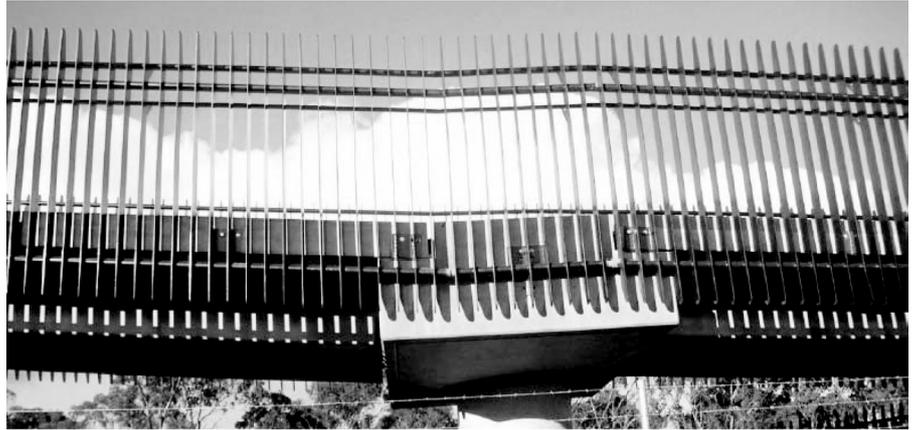
The balustrades consisted of a series of vertical fins spaced at 125 mm centres, with cylindrical horizontal supports near the top and bottom. Each fin was constructed from 6 mm thick steel plate, and was approximately 2 m long and 125 mm deep. A typical balustrade is shown in Figure 1.

Figure 1. *Finned Balustrade of Pedestrian Overpass.*

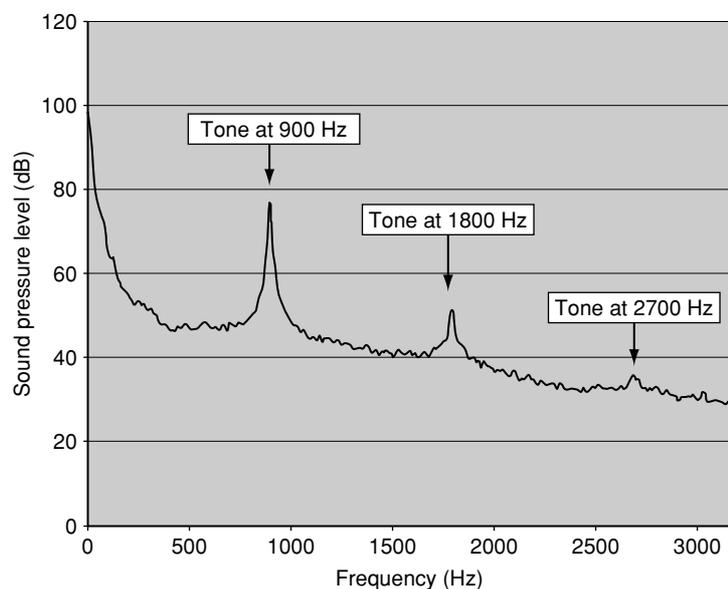
Initial data provided to the consulting team, in the form a recording of the noise that was taken by a site worker using a digital camera, provided preliminary information in relation to the characteristics of the noise. A Fast Fourier Transform (FFT) performed on this recording showed that the predominant frequency of noise was about 900 Hz, with harmonics at 1800 Hz and 2700 Hz, as shown in Figure 2.

Figure 2. *FFT of the Wind-Induced Noise.*

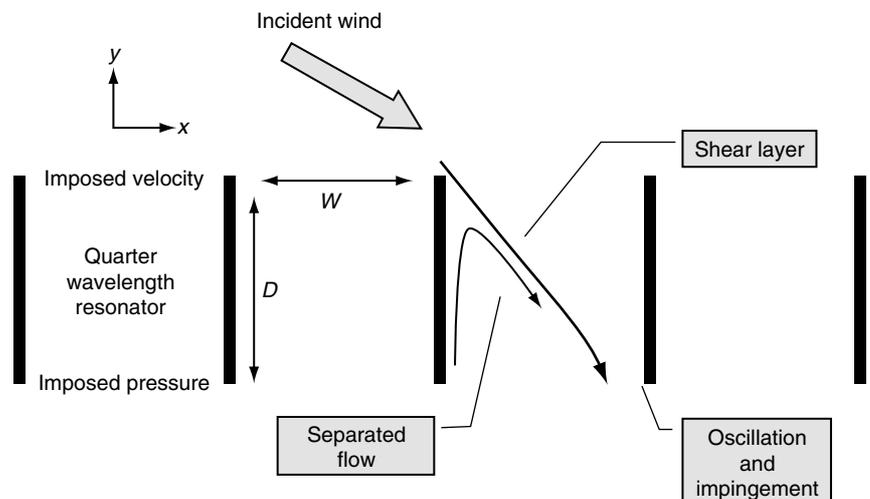
Based on a two-dimensional analysis of the flow around a balustrade panel as illustrated in Figure 3, it was assumed that a coupling was occurring between the shear layers originating from the sharp corner at the upstream edges of the balustrade fins, and the acoustic behaviour of the space delimited by two consecutive fins. For the purpose of the two-dimensional analysis, the width  $W$  is the distance between two fins, and the depth  $D$  corresponds to the thickness of the balustrade panels, which in the present case is equal to the width of the fins.

Figure 3. Detailed Cross-section in Plan View Illustrating the Physical Parameters of the Balustrade and the Proposed Model for the Noise Generation Mechanism (from [4]).

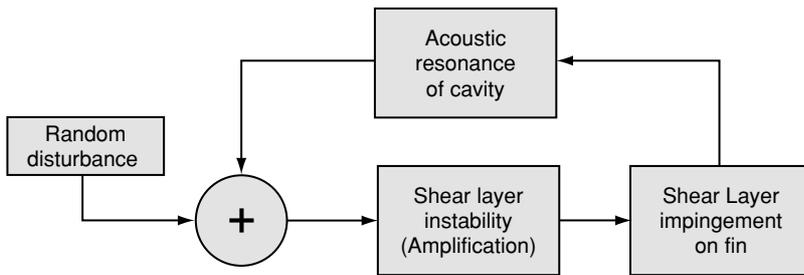
The feedback loop responsible for the observed tones is sketched in Figure 4.

Figure 4. *Block Diagram of Feedback Mechanism for Noise Generation.*

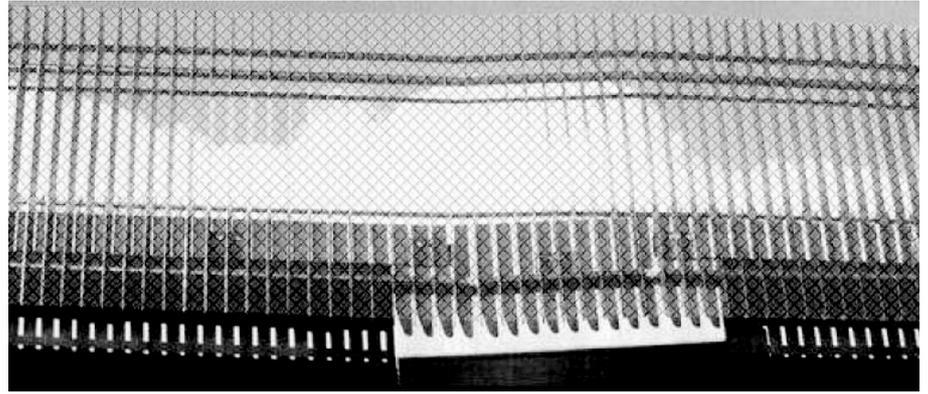
Figure 5. *Diagonal Wire Mesh Applied to Balustrade (Mock Illustration from [3]).*

**Option 4** was a more global approach. It was proposed that wire mesh could be attached to the balustrade panel as illustrated in Figure 5. A diagonal woven wire mesh of nominally 50 mm  $\times$  50 mm with a wire diameter of 2–3 mm was recommended, based on the characteristics of the flow and the frequency of noise generated.

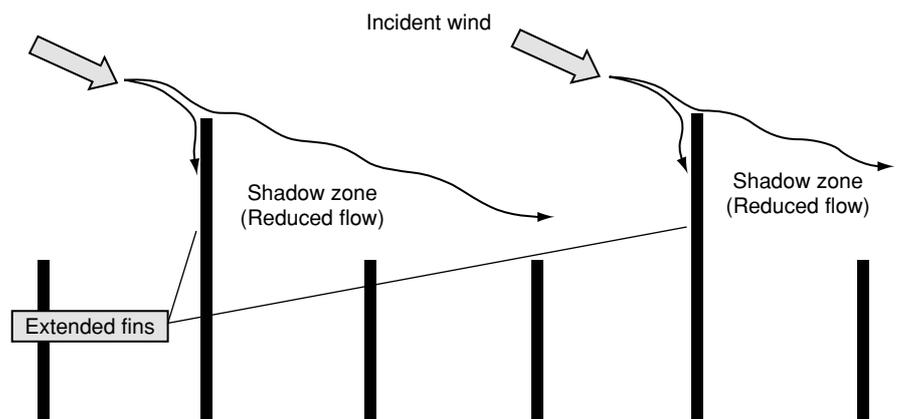
Figure 6. *Option 6: A Series of Deeper Fins Spaced Along the Balustrade.*

A final option, **Option 6**, which was suggested by the construction team, was to construct a series of deeper fins, spread along the length of the balustrade, to screen the incident wind from the unmodified fins in between (See Figure 6).

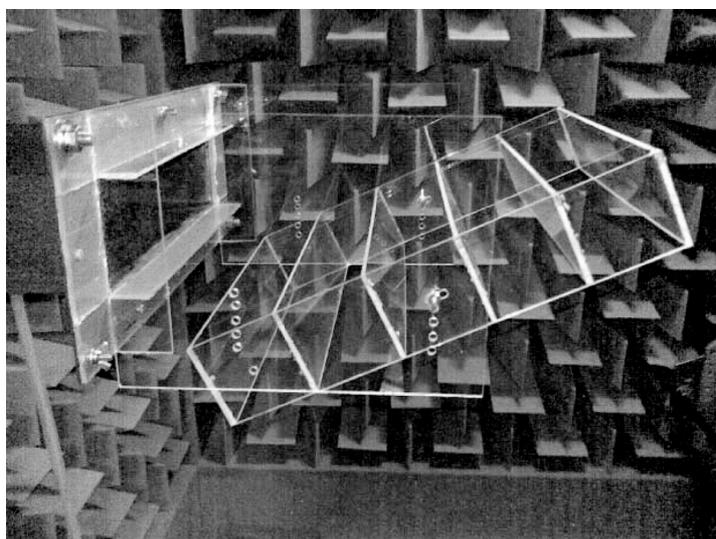
A half-scale model of a six-fin section of balustrade was tested in the small anechoic wind tunnel at the University of Adelaide as shown in Figure 7.

Figure 7. *Half Scale Model of the Balustrade in the Anechoic Wind Tunnel at the University of Adelaide [4].*

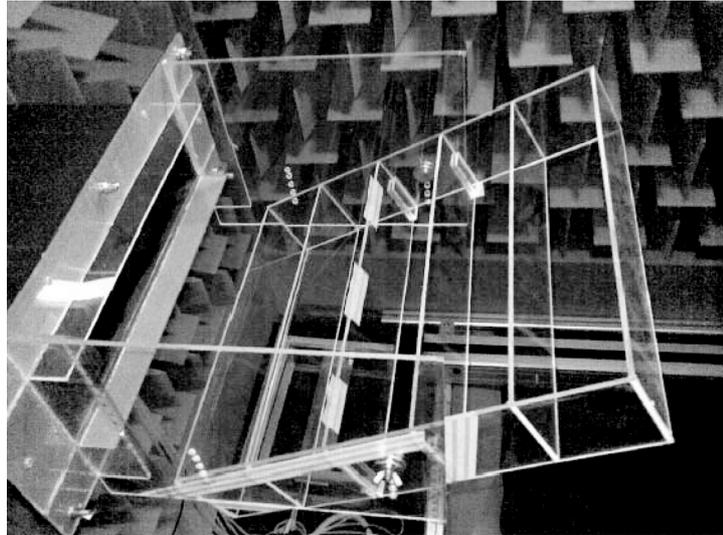
Figure 8. *Testing of Toothed Fin Edge with 50mm Pattern Length [4].*

In this test, the possibility of applying a material, such as a serrated, toothed, or otherwise irregular extrusion to the fin edge was investigated. Tabs of adhesive tape 50 mm long at 50 mm spacing, extending 5 mm beyond the edge of the fin, were used to represent the added material in the half scale case, as shown in Figure 8.

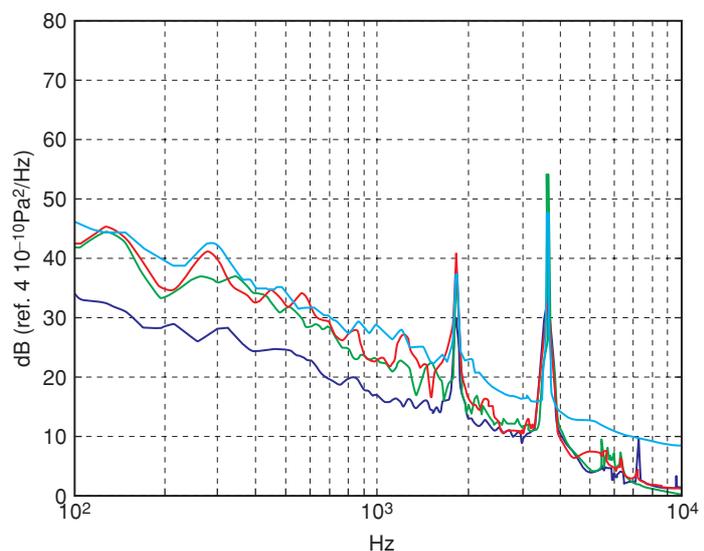
Figure 9. *Noise Spectra Measured at 17.5m/s, 26 degrees. Each colour corresponds to one of four microphone locations (from [4]).*

The test results, presented in Figure 10, showed that the tabs were quite effective in removing the tone, when compared to the original spectra presented in Figure 9.

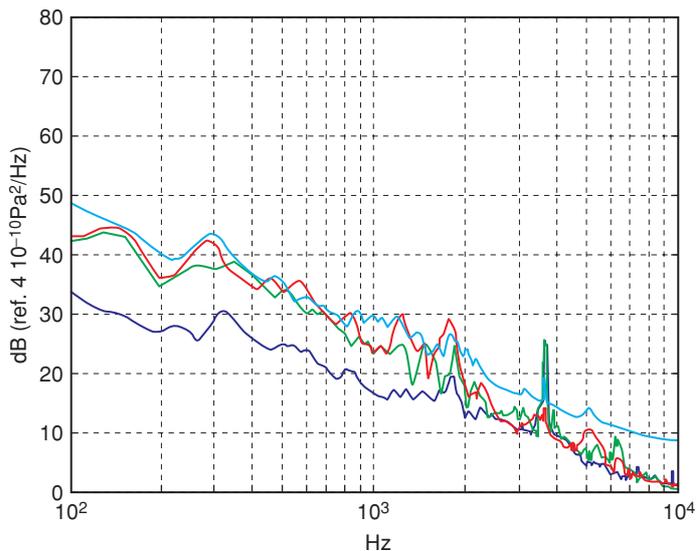
Figure 10. *Spectra Measured with Toothed Edge Fin with 50mm Pattern Length. Each colour corresponds to one of four microphone locations (from [4]).*

A brief investigation of the effect of reducing the tab length was carried out with tabs of 25 mm and 13 mm. The corresponding acoustic data showed an equally good reduction of the tones of interest if the flow configuration remained unchanged. In the case of the 13 mm tab, however, the tones reappeared when the angle of incidence was slightly reduced. This is thought to be because the spacing between

disturbances of the shear layer was too large. It was therefore suggested that an appropriate design rule would be to ensure that the characteristic length of the bead pattern (length and spacing) remains less than the distance separating two fins. As such, it was concluded that a 100 mm pattern length at full scale would provide adequate disturbance to the shear layer.

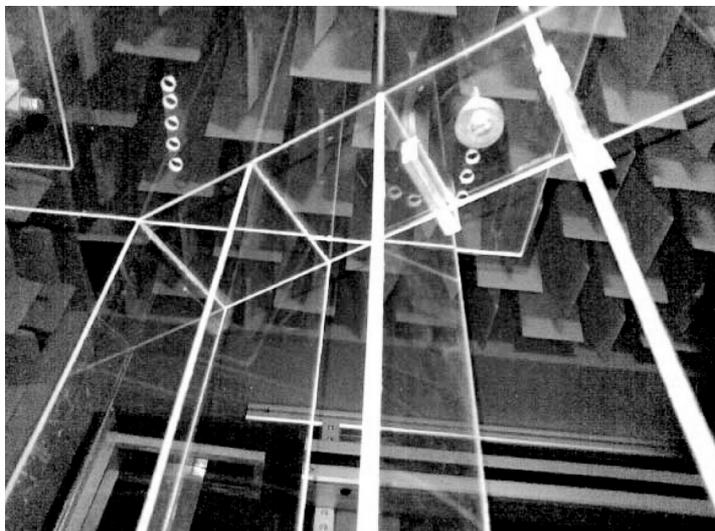
Figure 11. *Test with Rounded Fin Edge [4].*

In this test a half-round profile was added to the fin edge as shown in Figure 11.

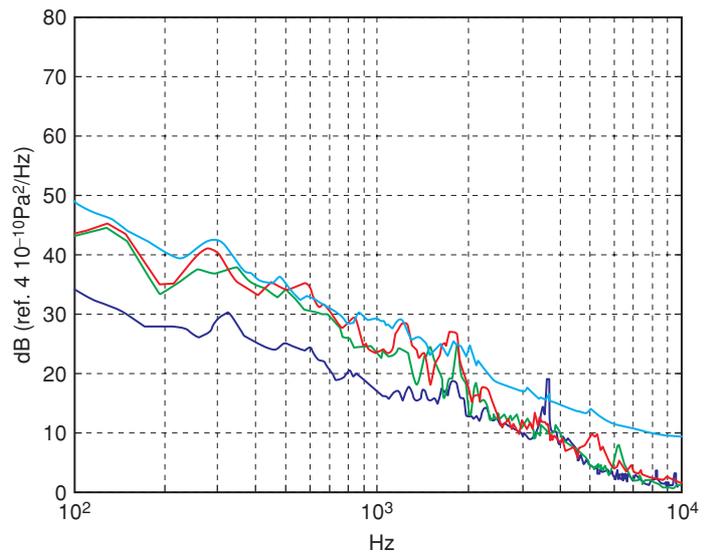
Figure 12. Spectra Measured with Rounded Fin Edge. Each colour corresponds to one of four microphone locations (from [4]).

This modification proved to be very effective in reducing the tone, as demonstrated by the spectra presented in Figure 12. However, while these results were very promising, it was noted that they might be adversely affected by environmental conditions on site, where a film of water, for example, could increase the edge surface smoothness and make the flow separation line more regular.

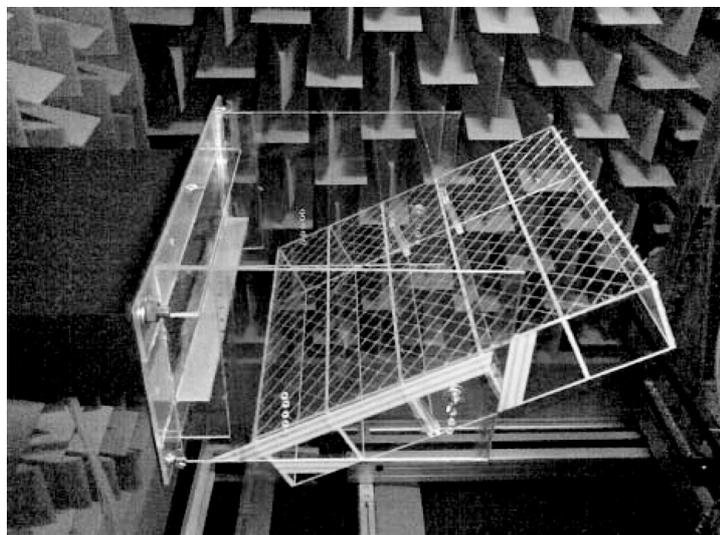
Figure 13. Wire Mesh Aligned Diagonally [4].

Testing of the wire mesh was performed with the mesh in two orientations – 1) diagonally relative to the balustrade fins

and 2) aligned with the balustrade fins as shown in Figure 13 and Figure 14, respectively.

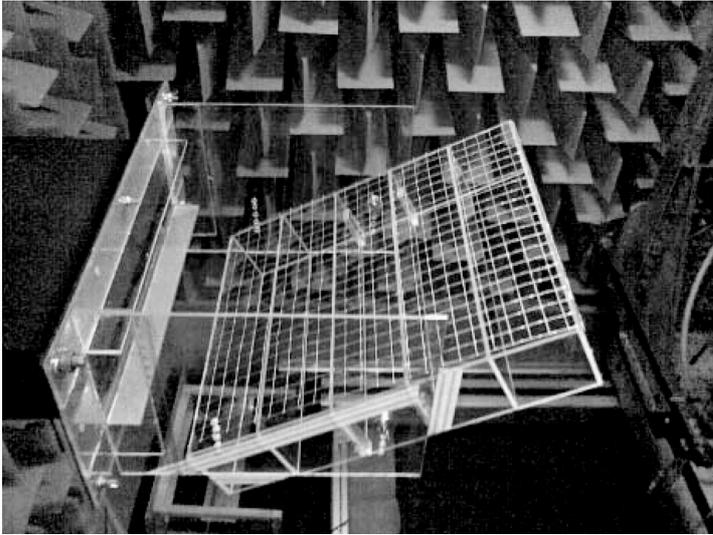
Figure 14. *Wire Mesh Aligned with Fins [4].*

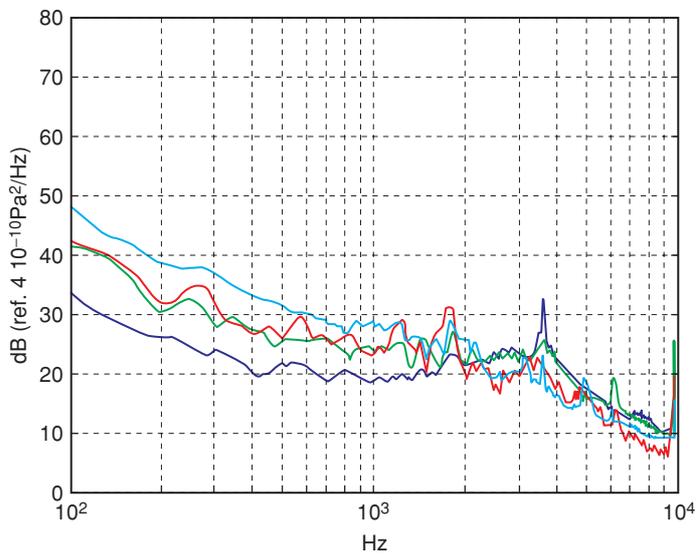
Both configurations were found to be effective in reducing the level of the tones observed. However, it was also noted that the mesh created an increase in broadband noise above 1 kHz. Figure 15 and Figure 16 present the measured spectra for each mesh configuration.

Figure 15. *Spectra Measured with Wire Mesh Aligned Diagonally. Each colour corresponds to one of four microphone locations (from [4]).*

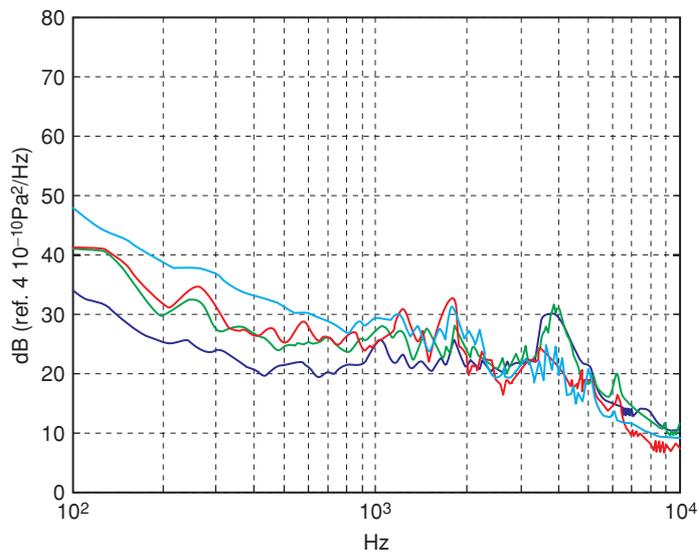
Figure 16. *Spectra Measured with Wire Mesh Aligned with Fins. Each colour corresponds to one of four microphone locations (from [4]).*

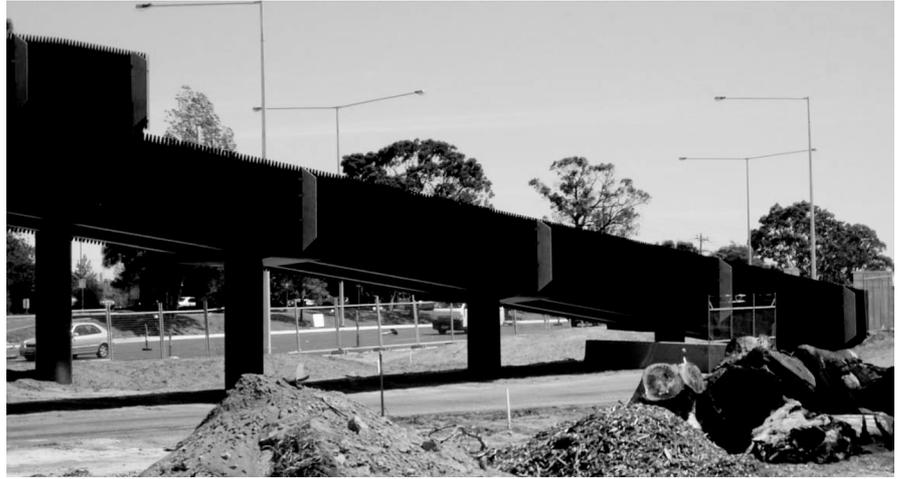
Figure 17. *Balustrade Fin Depth Extensions Installed on a Pedestrian Overpass.*

temporary 400 mm wide fin extensions were manufactured from plywood and installed on one of the affected pedestrian overpasses at a spacing of approximately one extended fin every 5 m (40 fins) as shown in Figure 17.

Re-occurrences of the noise under the same wind conditions following the installation of the fin extensions indicated that the fin extensions were not having any significant effect on the airflow across the majority of the balustrade. It is possible that decreasing the spacing of the extended fins to one every 0.4 to 0.5 m (every 3 to 4 balustrade fins) may have made this approach more successful, as increased sheltering of the unmodified fins from the wind would have resulted. However, this closer spacing was not deemed acceptable in terms of the urban design or the labour and cost that would be involved to complete the modification, so the idea was abandoned.
