Loss of Guide Wire: A Lesson Learnt Review of Literature

Rajiv Srivastav, Vishal Yadav¹, Dimpy Sharma¹, Vikas Yadav²

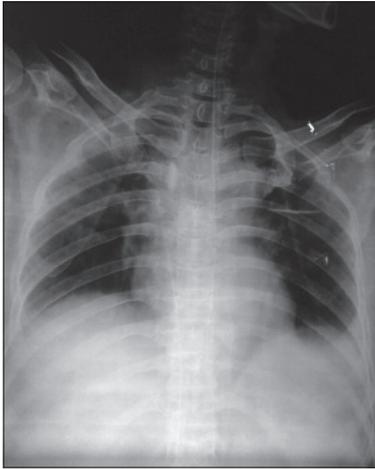
Figure 1: Chest X-ray showing guide wire of catheter had entered in the inferior vena cava (IVC) via the right internal jugular vein

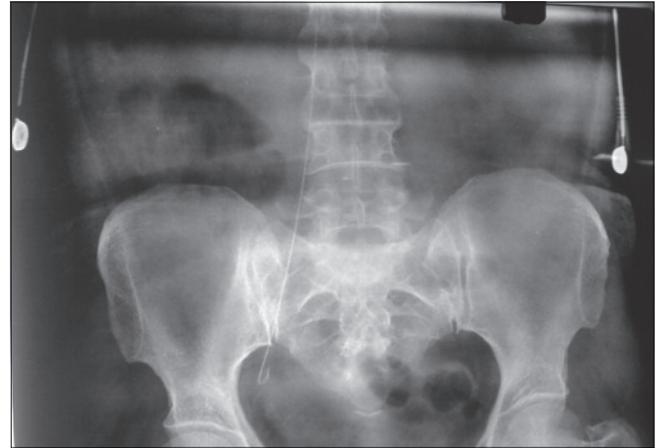
guide wire and its treatment. In our case, the catheter was retained in the right iliac vein at the point of bifurcation. An important point in preventing this rare complication is that the guide wire should be held at least 18 cm distant from the vein.^[3,5] If this rule is followed, the guide wire cannot get lost.

Figure 2: X-ray pelvis showing guide wire catheter had remained in the right iliac vein at the point of bifurcation into the internal and external iliac veins

entire guide wire should be possible to be removed in most cases. During the intervention the patient should be heparinized.^[17] Usually, the foreign body (e.g. guide wire) is caught by a gooseneck snare passed via the femoral vein using radiographic control. The use of endovascular forceps or a Dormier basket increases the risk of endovascular trauma.^[17] If the foreign body is captured, it is usually necessary to remove it along with the vascular sheath. If the vascular sheath is twice the size of the lost catheter or the lost guide wire may be possible to withdraw the foreign body through it.^[17] If heparinization is contraindicated, extraction should be attempted by careful surgical exploration.
