ENVIRONMENTAL CONSEQUENCES OF POOR RUNOFF MANAGEMENT IN S.E. NIGERIA*

CHUKWUNONYE O. OWUAMA

Federal University of Technology, Owerri, Nigeria

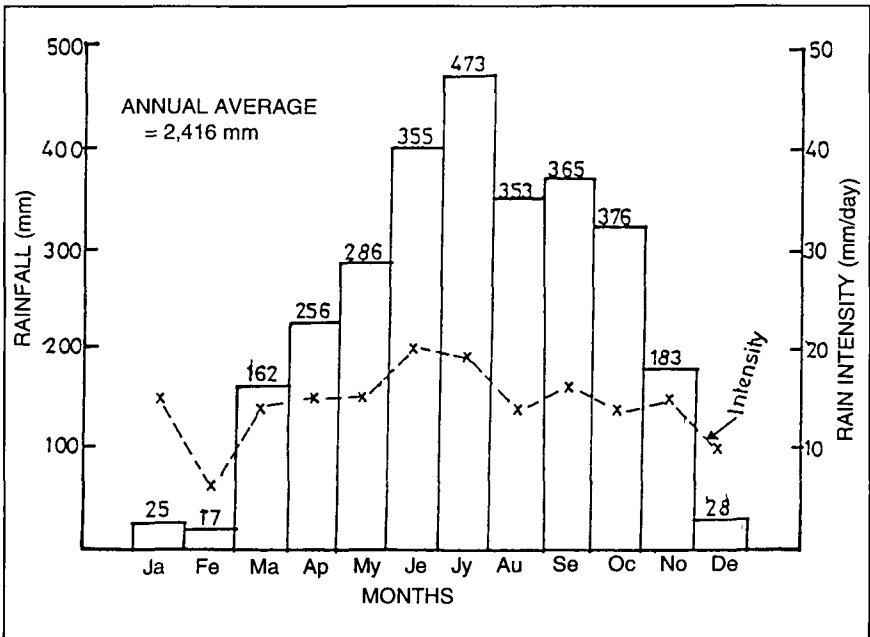
Figure 2a. Monthly average rainfall/rainfall intensity distribution for Calabar.

Climatic data from seven meteorological stations for ten years (1985-1994) were analyzed. The average monthly rainfall patterns for typical stations (Calabar, Umudike, Orlu) are shown in Figures 2a, 2b, and 2c. An annual average of approximately 2500 mm on the coast to 2100 mm in the interior was observed. Rainfall intensities (mm/day) are relatively high in the main rainy months of June to September. The mean annual temperature varies between 22°C and 33°C and the relative humidity is in the range of 75 percent and 99 percent.

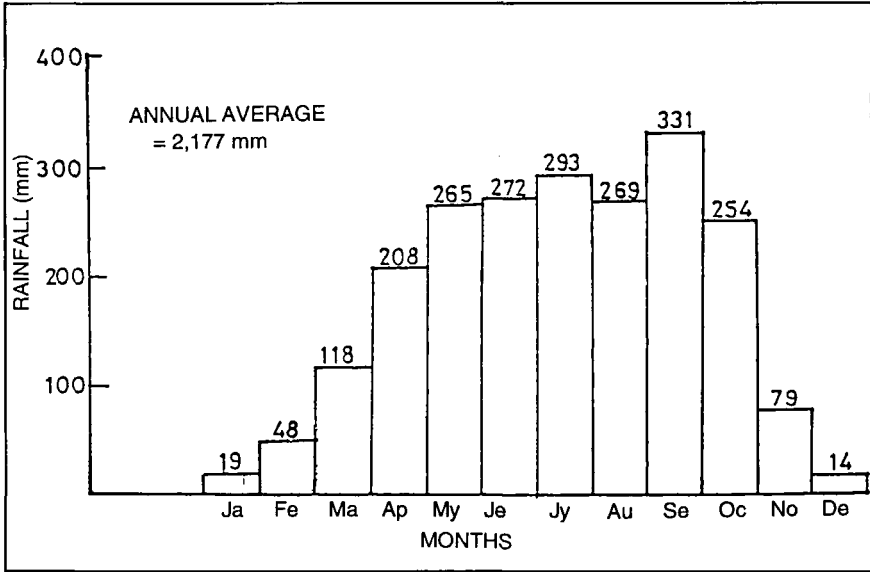
Figure 2b. Mean monthly rainfall (mm) for Umudike.
