# Case Report

## Septic failure is not a septic loosening: A case report of a failed shoulder prosthesis

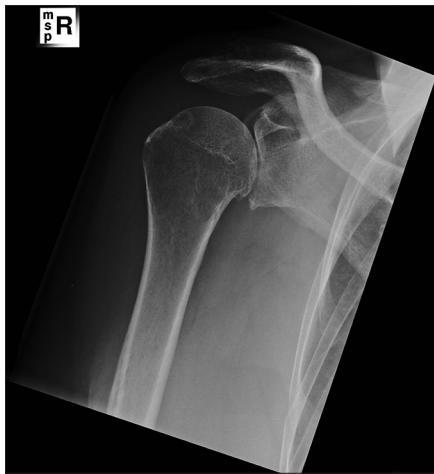
**Figure 1:** AP X-ray of the right shoulder showing osteoarthritis of the glenohumeral joint

A 70-year-old woman presented at our outpatient department with primary glenohumeral osteoarthritis at the right side [Figure 1]. She had osteoarthritis in multiple joints and underwent previously a bilateral total knee replacement. General medical history revealed diverticulitis, mild chronic obstructive pulmonary disease (COPD), and atrial fibrillation.

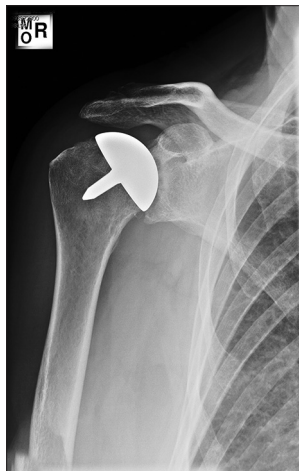
**Figure 3:** Two years postoperative, the X-ray shows progressive glenoid erosion with a well-positioned prosthesis

neither inspected nor aspirated. However, the subacromial decompression did not relieve the complaints and the range of motion gradually decreased. At 2 years after the arthroplasty, the patient had pain on the anterior side of the shoulder, mild rest pain, increased pain whilst lifting, and a restricted forward flexion of 90° and external rotation of 50°. No clinical infectious signs were present and the cuff seemed intact. Her erythrocyte sedimentation rate (ESR) was slightly elevated since the first operation (between 30 and 45) with a normal C-reactive protein (CRP). However, the biochemical markers are not completely reliable for an infection due to her diverticulitis. The X-rays showed a well-positioned prosthesis without signs of loosening and some progression in glenoid erosion [Figure 3]. To exclude an infection, a culture of intra-articular fluid (obtained by fine-needle aspiration) was done, which was negative.

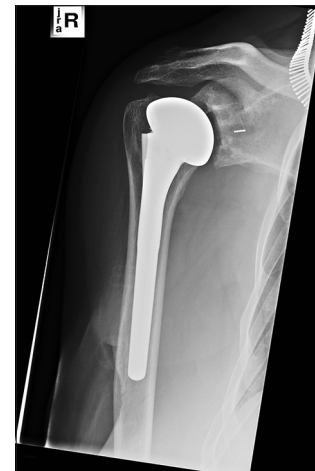
**Figure 4:** Postoperative situation after conversion to a total shoulder prosthesis

Because of the persisting pain and signs of progressive of glenoid erosion on plain radiographs, a conversion from hemi to total shoulder prosthesis was performed [Figure 4]. Three times

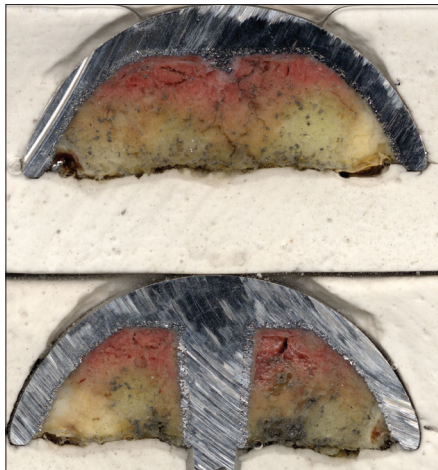
photographed. A microscopic stable prosthesis with full osseointegration was seen. The bone was intact, generally osteoporotic, and in good contact with the coating of the prosthesis. There were no signs of soft tissue interface formation due to loosening or microfractures of the bone trabeculae [Figures 5-8].

**Figure 5:** Cross-sections of the uncemented resurfacing shoulder prosthesis (DePuy; Global Cap). Most tissue under the cup is fatty marrow with some scarce and thin bone trabeculae

In our case, the histological analysis of the shoulder prosthesis did not fit the standardized histological classification. This was due to the fact that we did not find a periprosthetic interface as the bone was fully integrated onto the hydroxyapatite-coated undersurface of the prosthesis. This is in contrast to the theory that an infection leads to interface formation and subsequently loosening of the prosthesis.

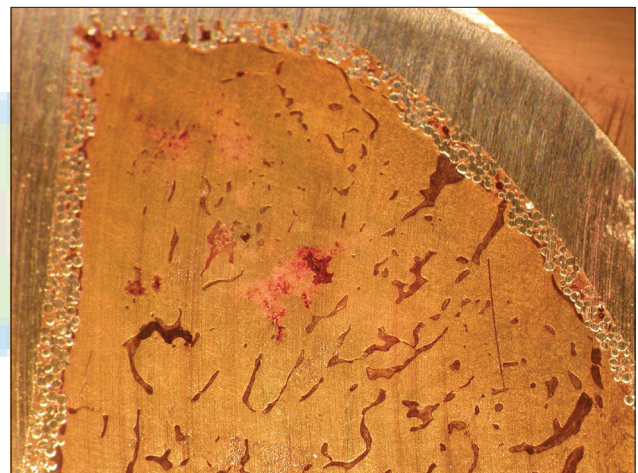
**Figure 6:** Enlargement of area directly under the cup. Notice bone trabeculae running in the direction of the porous coating of the cup

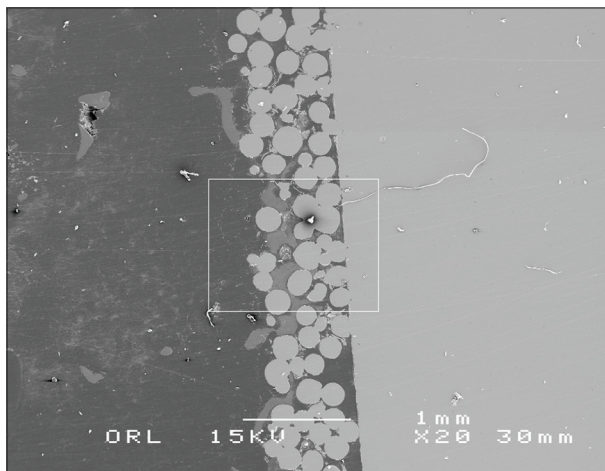
**Figure 7:** Low magnification of plastic embedded and polished surface of area directly under the porous coating

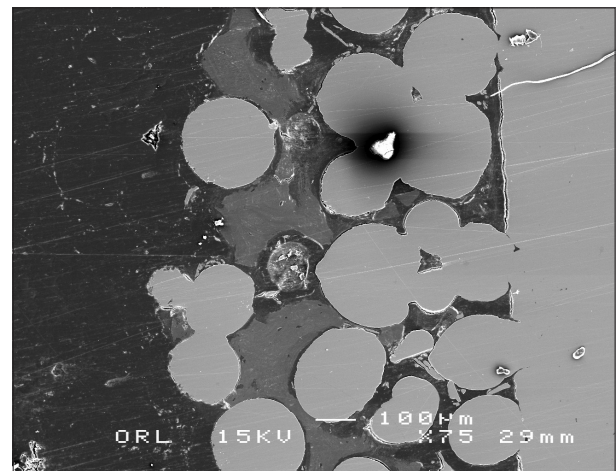
**Figure 8:** Higher magnification of boxed area in Figure 3 showing bone trabeculae in close contact with the porous coating

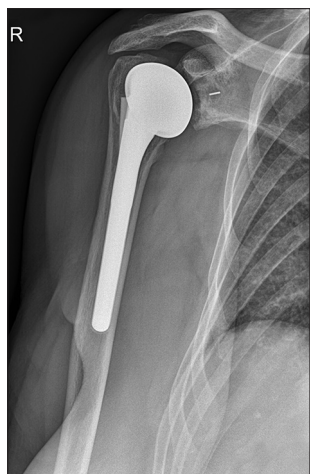
These findings led to the conclusion that the resurfacing prosthesis failed due to a painful low-grade infection, without loosening of the prosthesis. According to the advice of the microbiologist, prolonged antibiotic regiment was started until the ESR and CRP normalized after 3 months. The rehabilitation period was longer than after the first operation, but uneventful and no wound problems occurred. At the last follow-up, 24 months postoperative, she was satisfied with her shoulder. She had a pain-free active forward flexion of 140°, endorotation of 70°, and exorotation of 30°. There were no clinical or biochemical signs of infection and the X-ray showed a correct position of the prosthesis with no signs of loosening [Figure 9].

**Figure 9:** X-ray 2 years postoperative after total shoulder prosthesis
